NBSIR 81-2324 (R)

# Boiling Tests of Non-Asbestos-Based Thermal Insulation Used in Air-Conduit Underground Heat Distribution Systems

September 1981

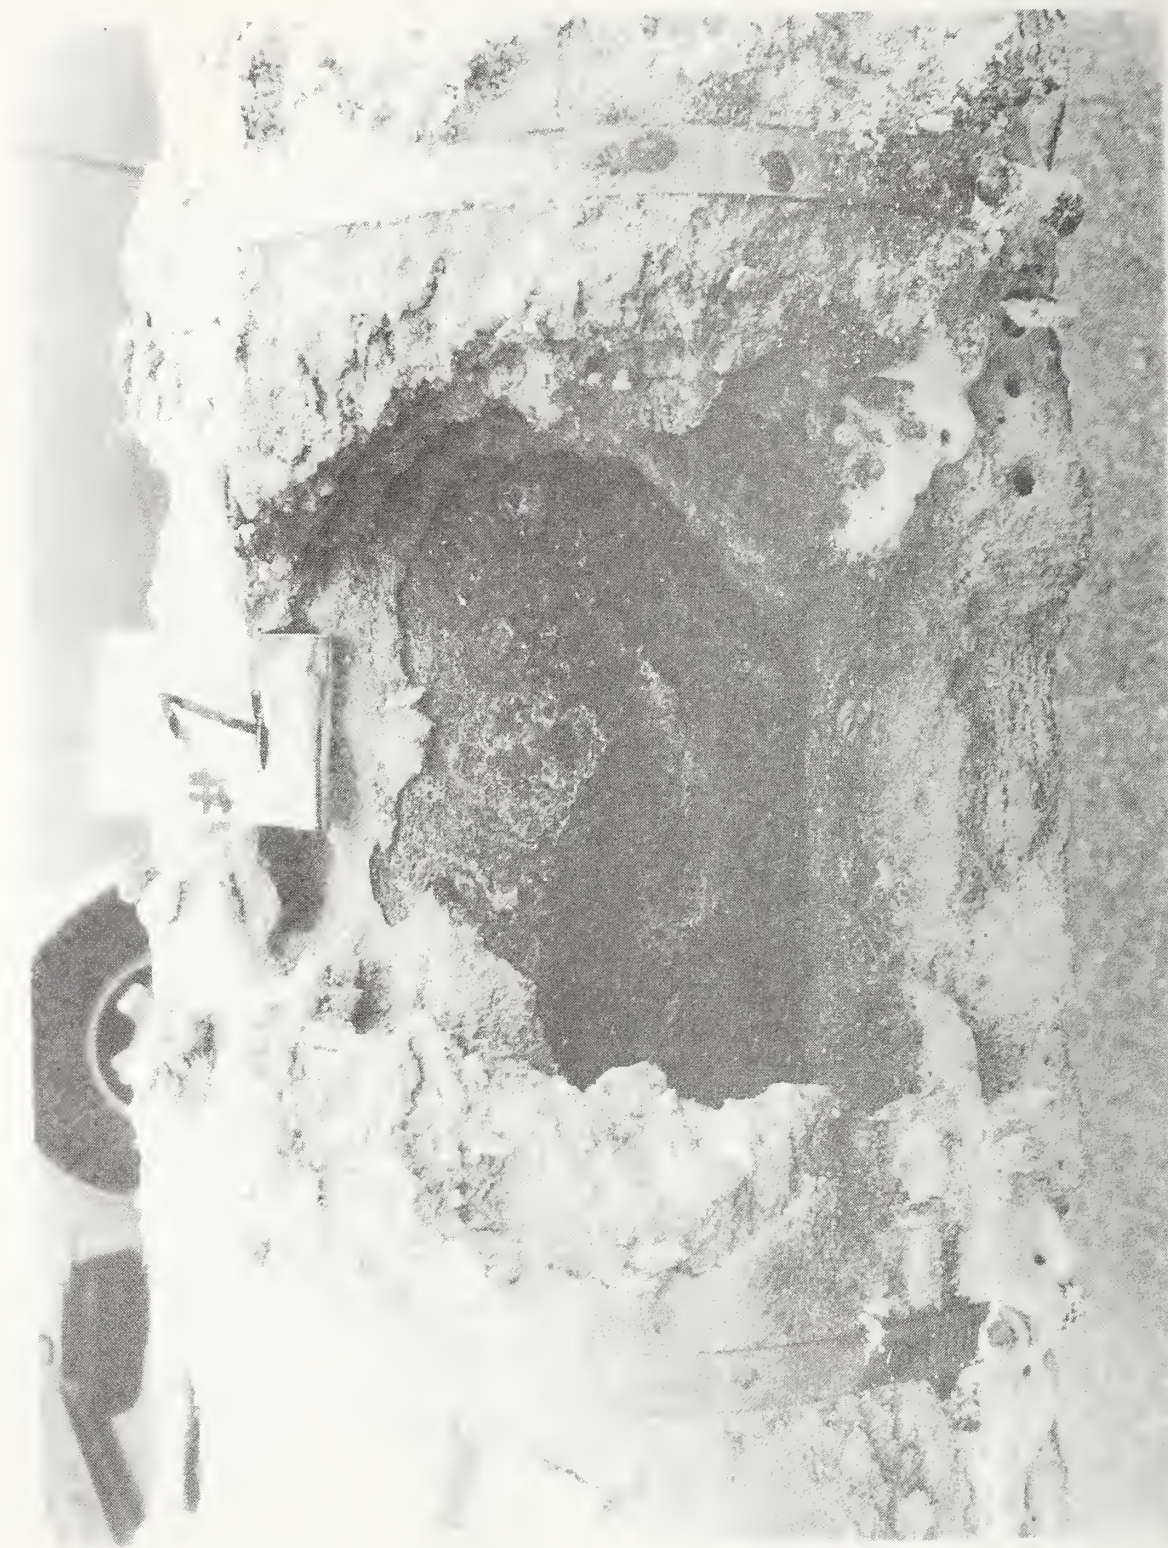
Insulation Material	Days Boiling			
	8	16	24	32
				64
Celotemp 1500 Celotex Corp. Expanded perlite	Started breaking apart Figure 61	Final run insulation 50% off of pipe. Figure 62	---	---
Thermo-12 Johns-Manville Calcium silicate	No physical damage visible to insulation.	Started to show damage. Figure 63	Increased damage apparent. Figure 64	Continuous damage apparent. Figure 65
Epitherm 1200 Eagle-Picher Mineral wool	Slight damage apparent Figure 67	Slightly increased damage. Figure 68	Damage at support on end. Figure 69	Slight increased damage. Figure 70
Wesolite "D" Wesolite Co. Perlite/sodium silicate	Damage below water level. Figure 72	Joint opening slightly Figure 73	Slight damage at joint. Figure 74	Damage at end of section. Figure 75
Super Caltemp Pabco Calcium silicate	No physical damage visible to insulation.	Cracks visible in insulation. Figure 77	No increase in damage visible. Figure 78	Damage below water level. Figure 79

Figure 62. Celotemp 1500 after 16 days of boiling.

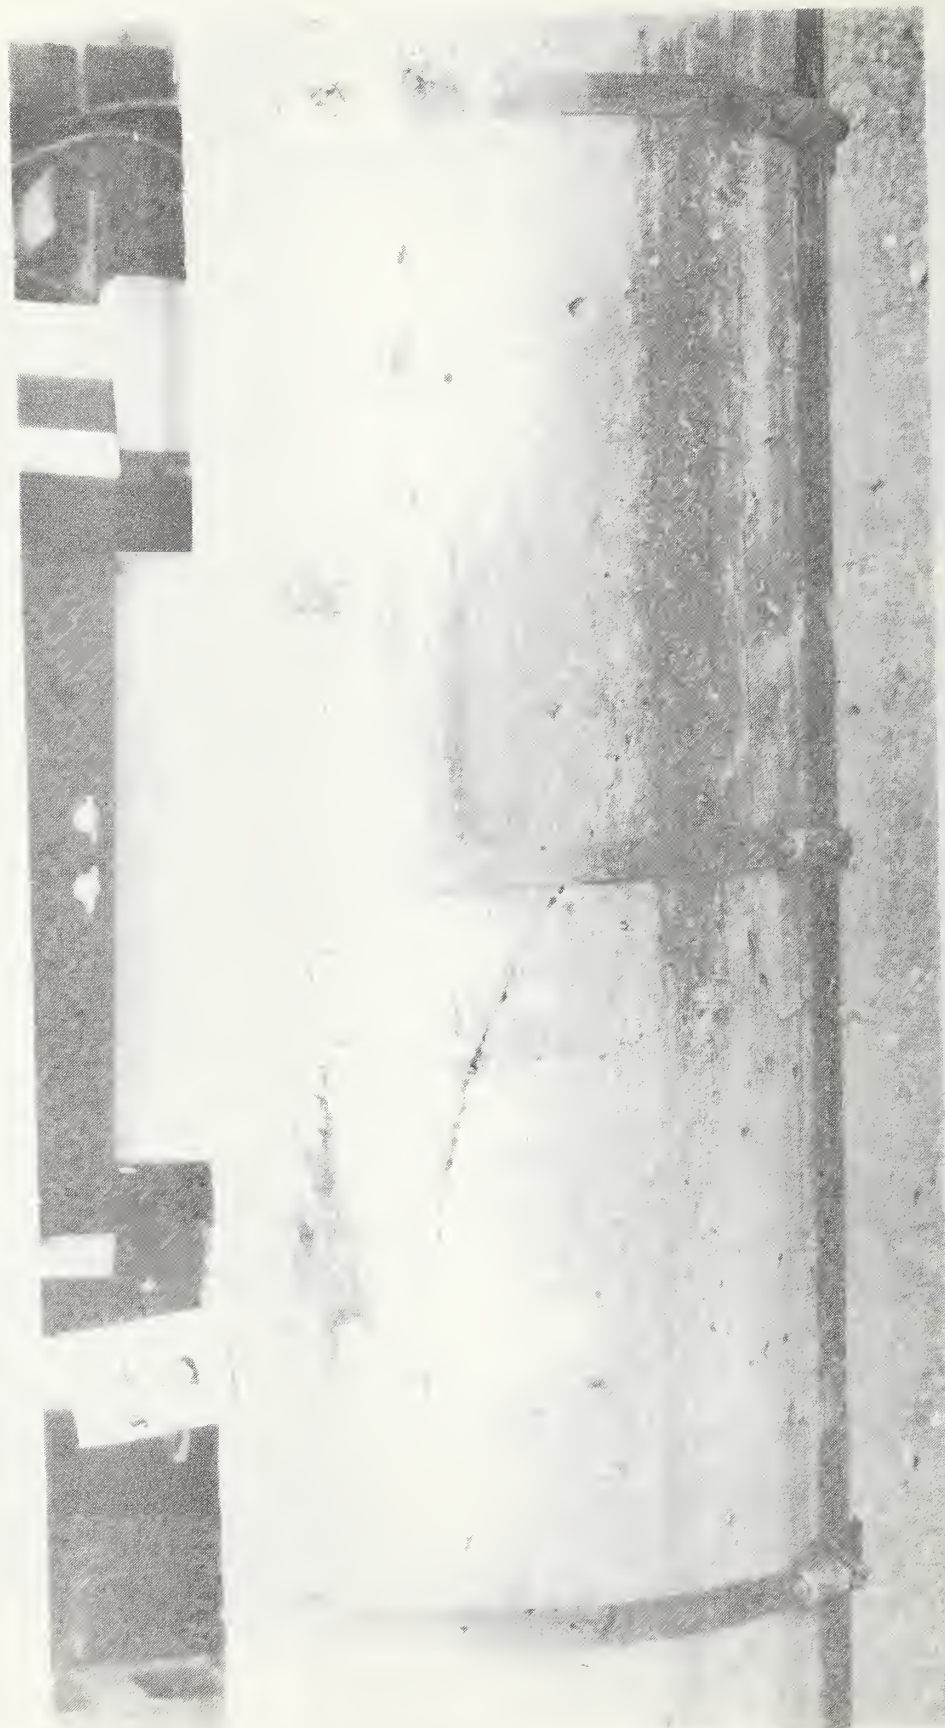
Figure 78. Super Caltemp after 24 days of boiling.

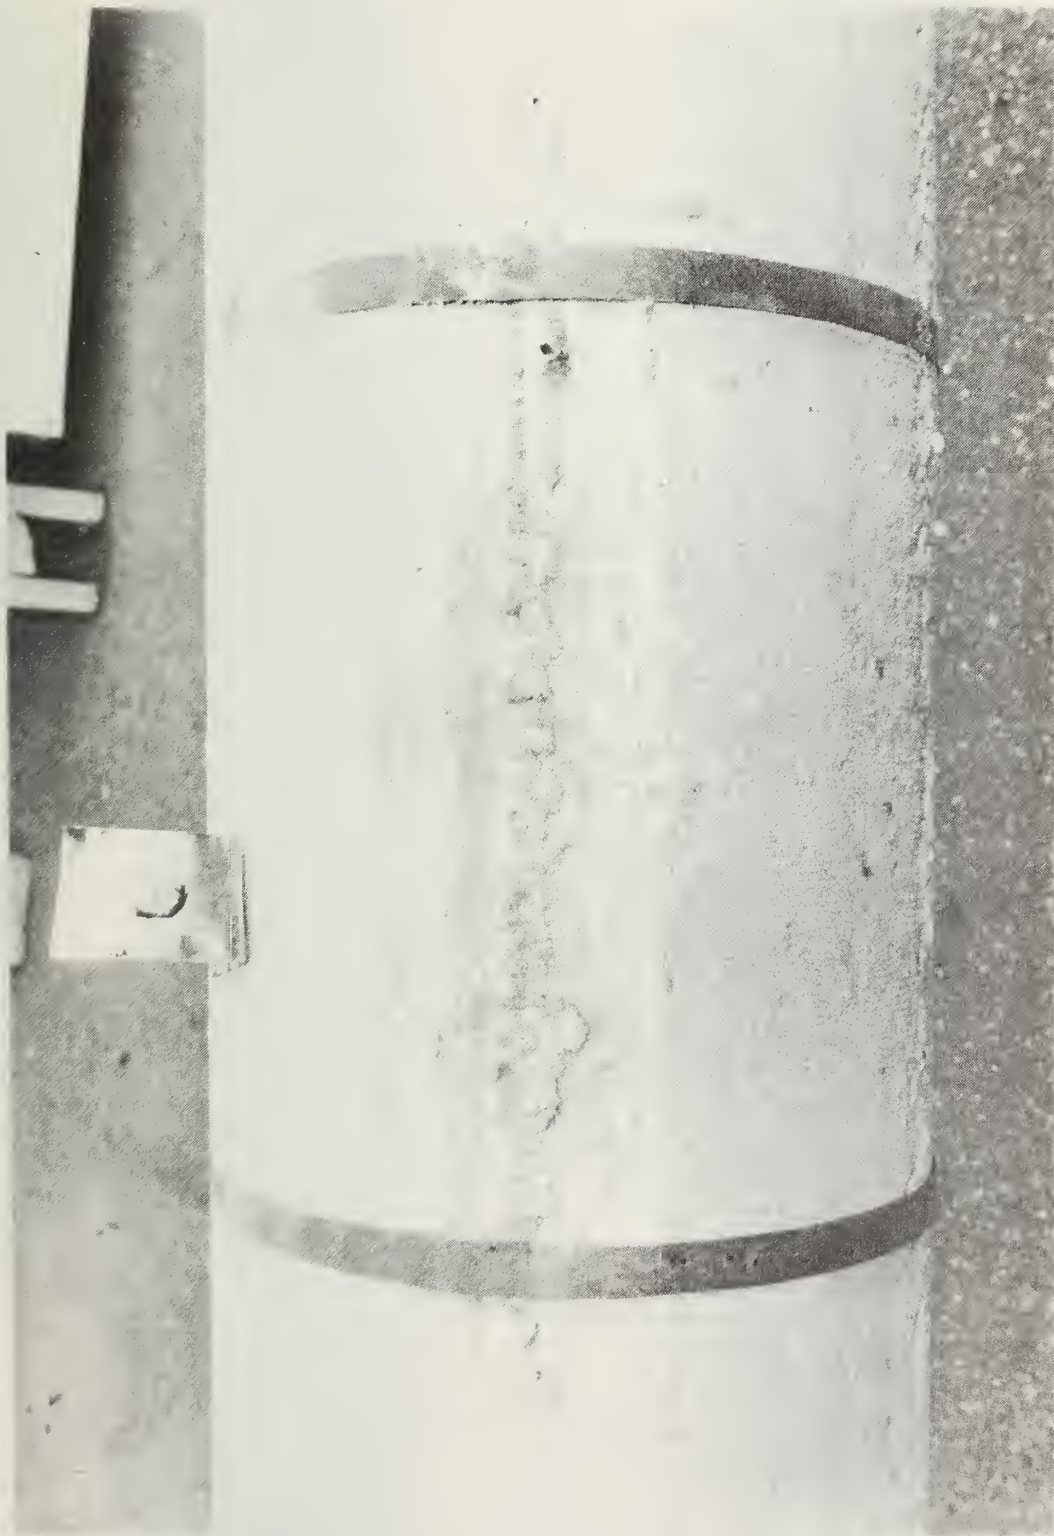
Kaylo-10 Owens/Corning Calcium silicate	No physical damage visible to insulation.	Slight damage visible. Figure 81	Damage at joint visible. Figure 82	Joint starting to open up. Figure 83
				Increased opening at joint. Figure 84

Figure 81. KAYLO-10 after 16 days of boiling.
